Inner-German Border (IGB)

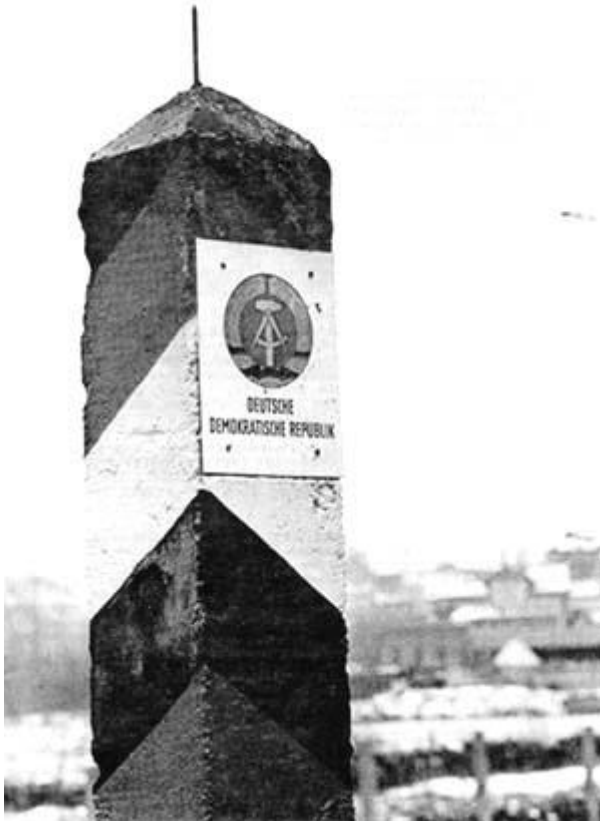
German Democratic Republic border marker.

The inner-German border, after the work of the Grenzekommission was essentially completed in 1975 (see above), was identifiable from both the ground and the air for those familiar with its complex series of border area markings and structures. The actual border was marked with plain white granite border trace or survey stones. In addition, there were historic border marking stones of Saxony, Hesse, and Prussia that may or may not have marked the border accurately, depending upon the circumstances of each stone or subsequent agreements.

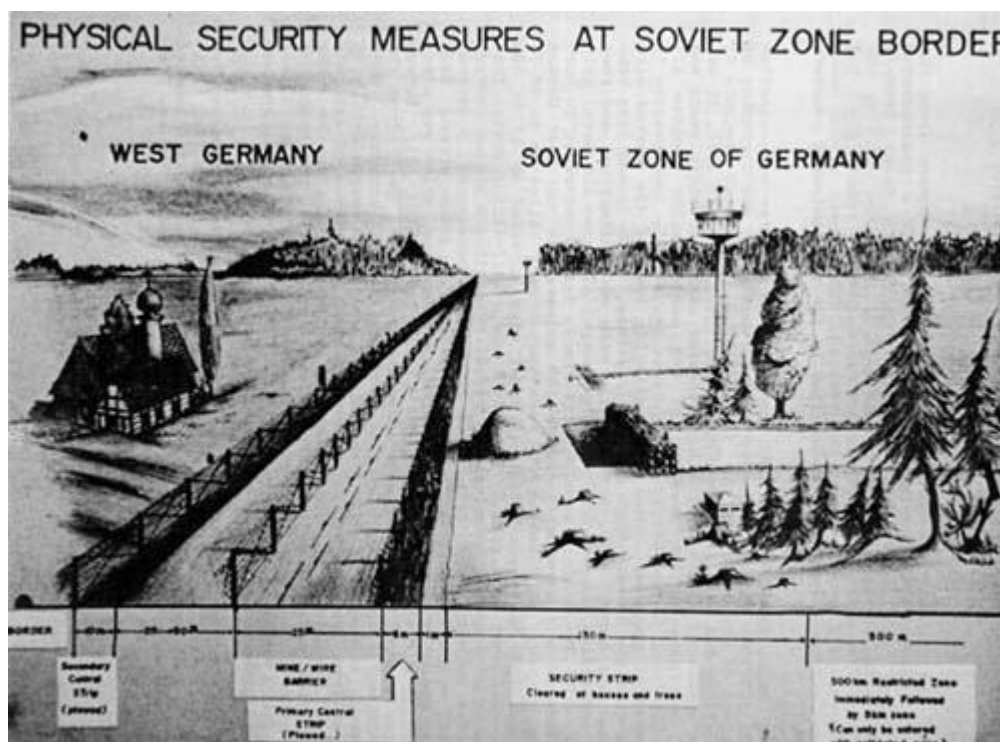
FIGURE 9

Prior to 1972, the East German border barrier modernization program had been viewed primarily as a strengthening and upgrading of weak areas of their old system. (See FIGURE 9.) Although elements of a new system had been going up since the program began in 1967, it was in the summer of 1972 that the East Germans seemed to shift gears and began incorporating improvements of the modernization program all along the inner German border. There were two notable improvements in the expanded program: they were replacing most of the barbed wire fences with the 3-meter high metal grid fences, which looked less brutal than the barbed wire, but actually were more effective; and they began installing the new SM-70 antipersonnel mines on the metal grid fences. The SM-70 mines were a particularly lethal deterrent to border crossers and eventually became the mainstay in the East German barrier system.

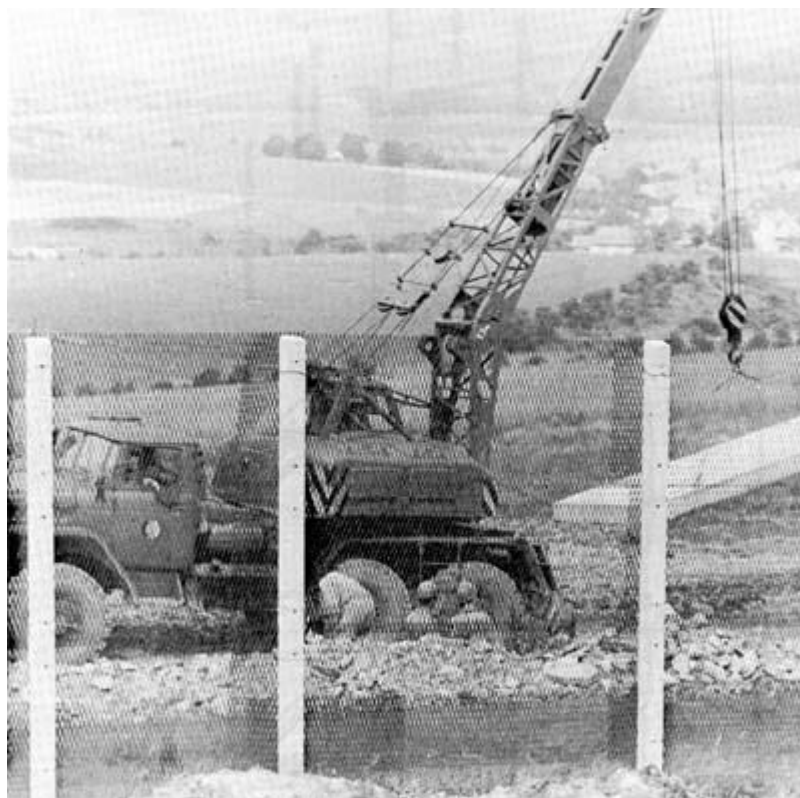
In the early 1970s, the barbed wire fences along the inner-German boundary were replaced by wire mesh fences.
